Manhole Inspection Summary

Manhole # S47G2_001MH

Insp Date: **1/22/08 9:38 AM**

Location Address: **4501 Curtis Ave.**

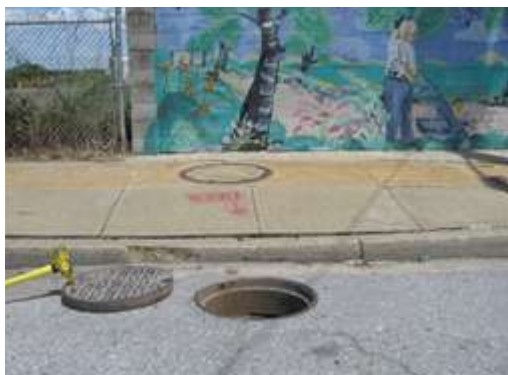
Location View

4501 Curtis Ave.

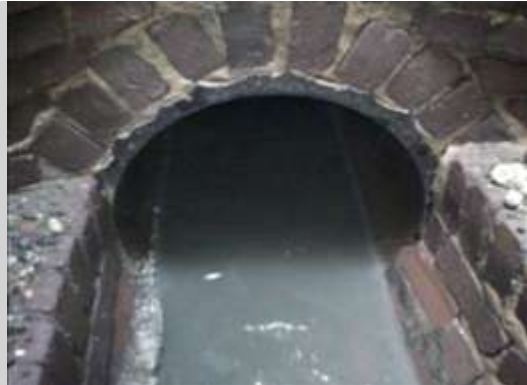
12 O'Clock Outflow

18 in. Circular Gravity Sewer
Pipe Out @ 12 O'Clock

Pipe Height: **18** (in.) Rod and Bar (Angled)
Pipe Material: **Clay** ☐ Pipe Lined
Invert Depth: **16.29** (ft.) Flow Characteristics: **Fast**
Deposits: ☒ None ☐ Mud ☐ Sludge ☐ Debris ☐ Grease
Silt Depth: (in.) Deposits Extent:
Infiltration: **None** Pipe Seal Cond: **Sound**

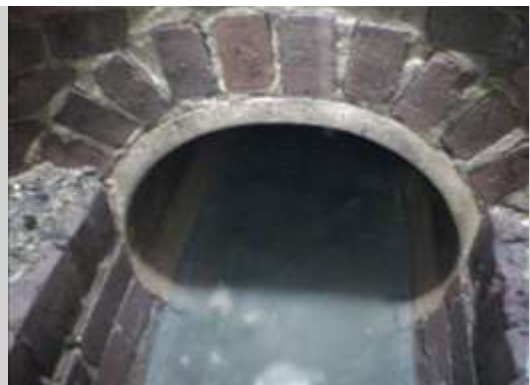
6 O'Clock Inflow

18 in. Circular Gravity Sewer
Pipe In @ 6 O'Clock

Pipe Height: **18** (in.) Rod and Bar (Angled)

Infiltration: **None** Pipe Seal Cond: **Sound**
